NYC Department of Buildings  
Forensic Engineer Unit  
Timothy Lynch, PE  
280 Broadway,  
New York, NY 10007

# Engineering Report

## Wards Bakery Parapet Collapse

### 800 Pacific Street, Brooklyn

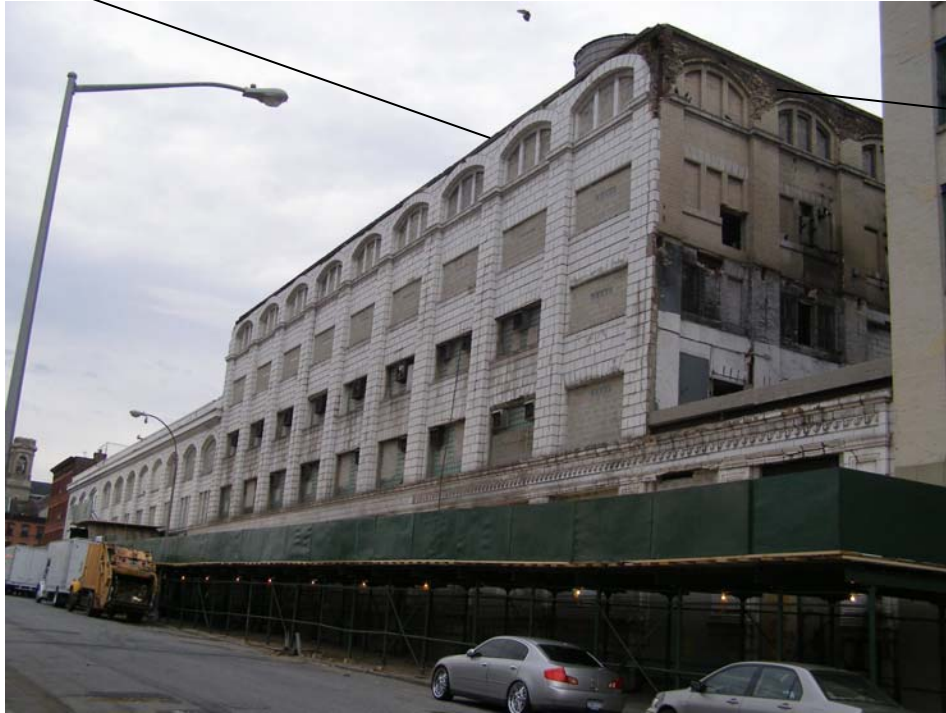
Parapet  
collapse  
along Pacific  
St.

Unsafe  
parapet  
removed  
along sides of  
building.

Photo 1 shows the entire Pacific St parapet lost due to collapse.

Based on the parapet failure, the owner's engineer and demolition contractor are now "front ending" removal of the remaining portions of the parapets prior to the remaining asbestos abatement. This procedure should have been adopted earlier. The remainder of the building can be safely demolished with usage of standard demolition techniques and safeguards.

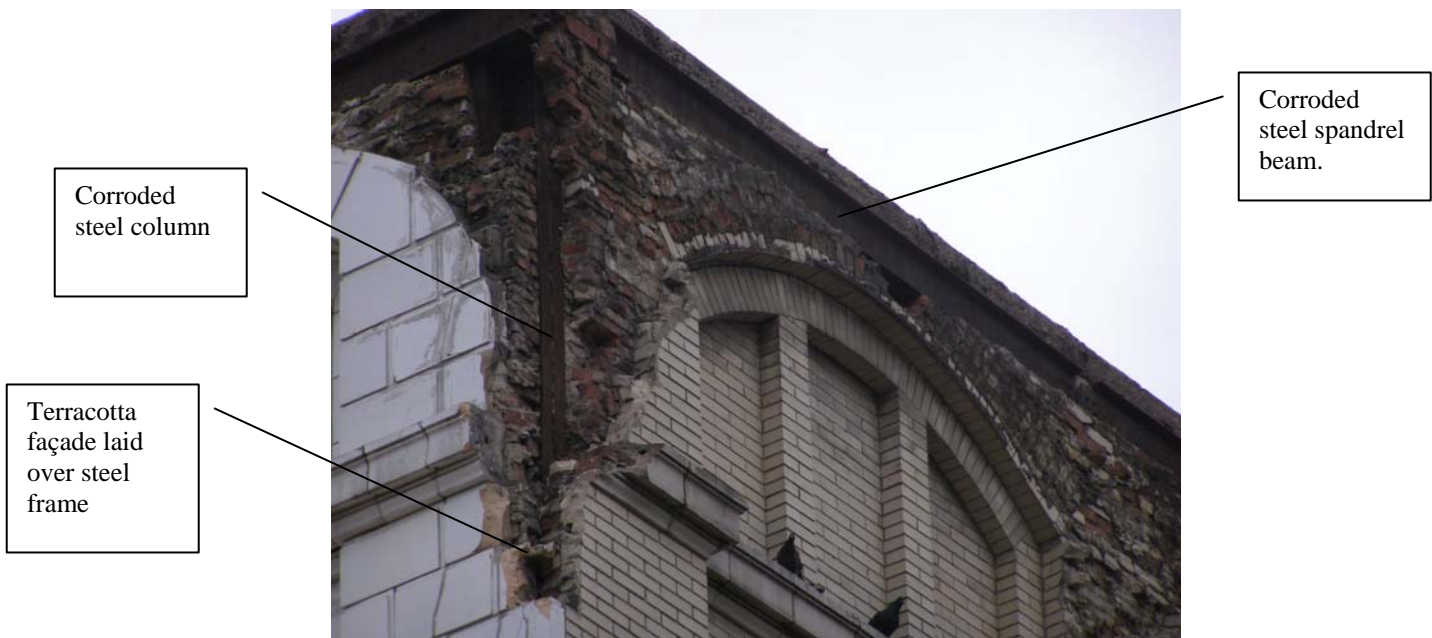
Corrosion of structural steel: Reviews of the façade indicate that long term water infiltration through the terracotta and brick led to long term corrosion of the structural steel frame located between 4" to 8" behind the face of the building (see Photo 4 below).

Photo 4 shows the close relationship between structural steel and ornamental façade

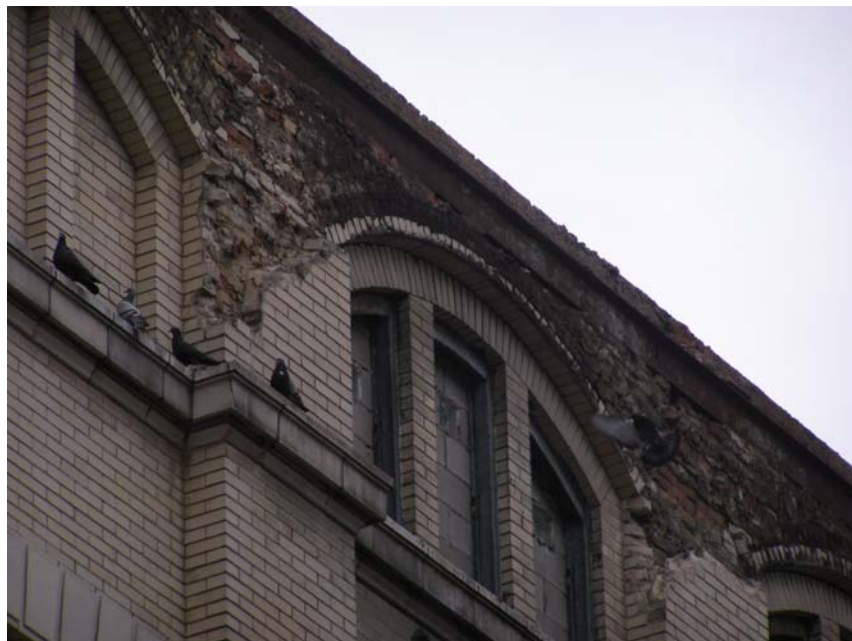
As steel becomes saturated with rain water, steel rusts. As it rusts, the steel increases in volume. This increase in volume creates pressure against the brickwork fixed to the steel. Over a period of years, this “jacking” action eventually can snap the exterior brickwork and the brick falls off the building to grade.

Photo 3 shows failed brick on façade.
